# Improving drainage of Continuous Renal Replacement Therapy effluent bag in Sengkang General Hospital Intensive Care Unit

Singapore Healthcare Management 2024

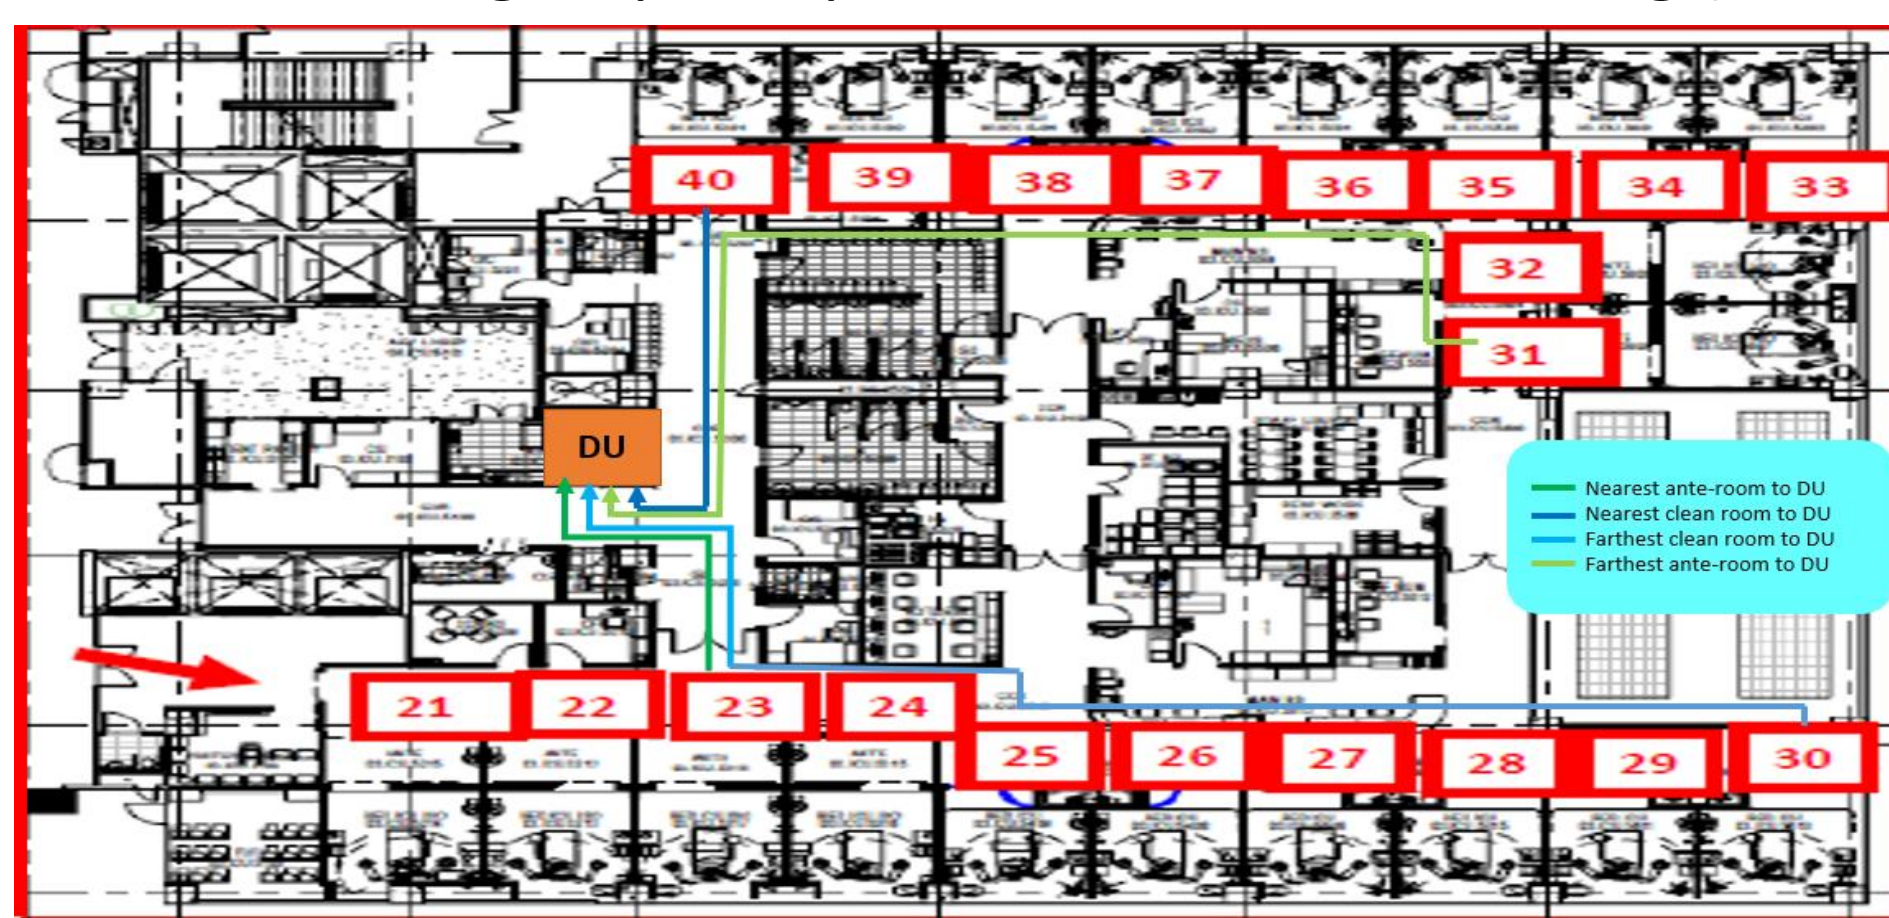
**Floor Map 1:** Routes of a nurse walking from nearest and furthest patient's room to DU

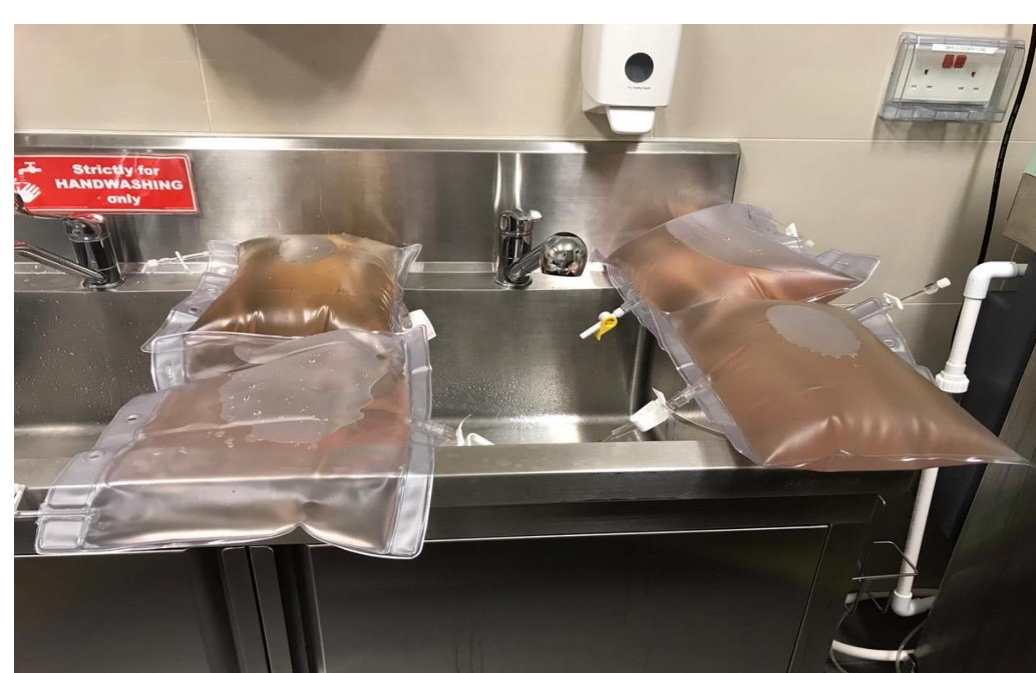
- The designated sink at DU is not designed to hold the effluent bag during drainage, which allows the bag to fall and cause body fluid spillage on the floor.
- Housekeepers have reported that effluent bags had fallen and spilled contents at least 8 out of 10 times.

**Picture 1:** Effluent bag placed at side of sink.

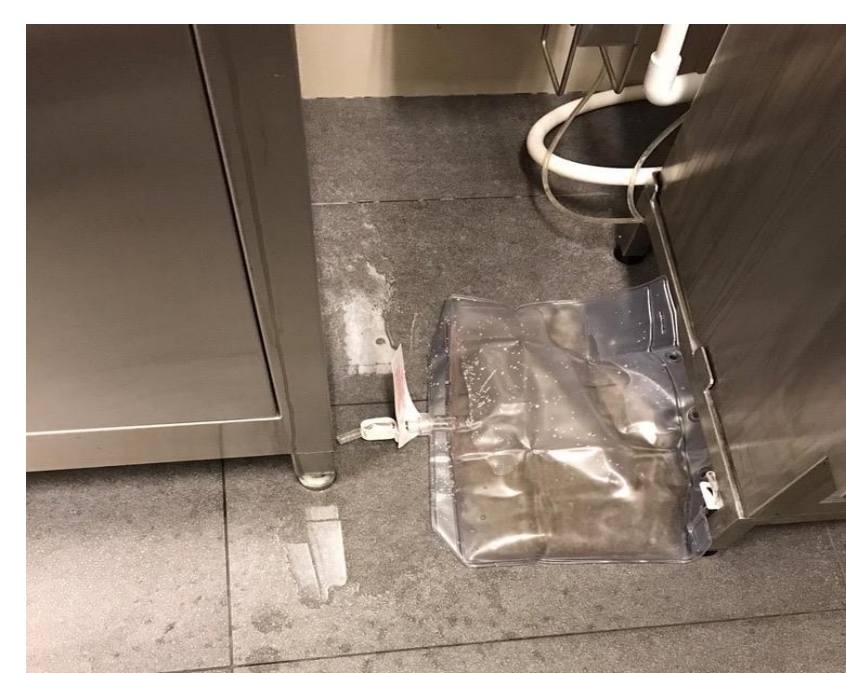
**Picture 2:** Spillage of effluent bag on floor

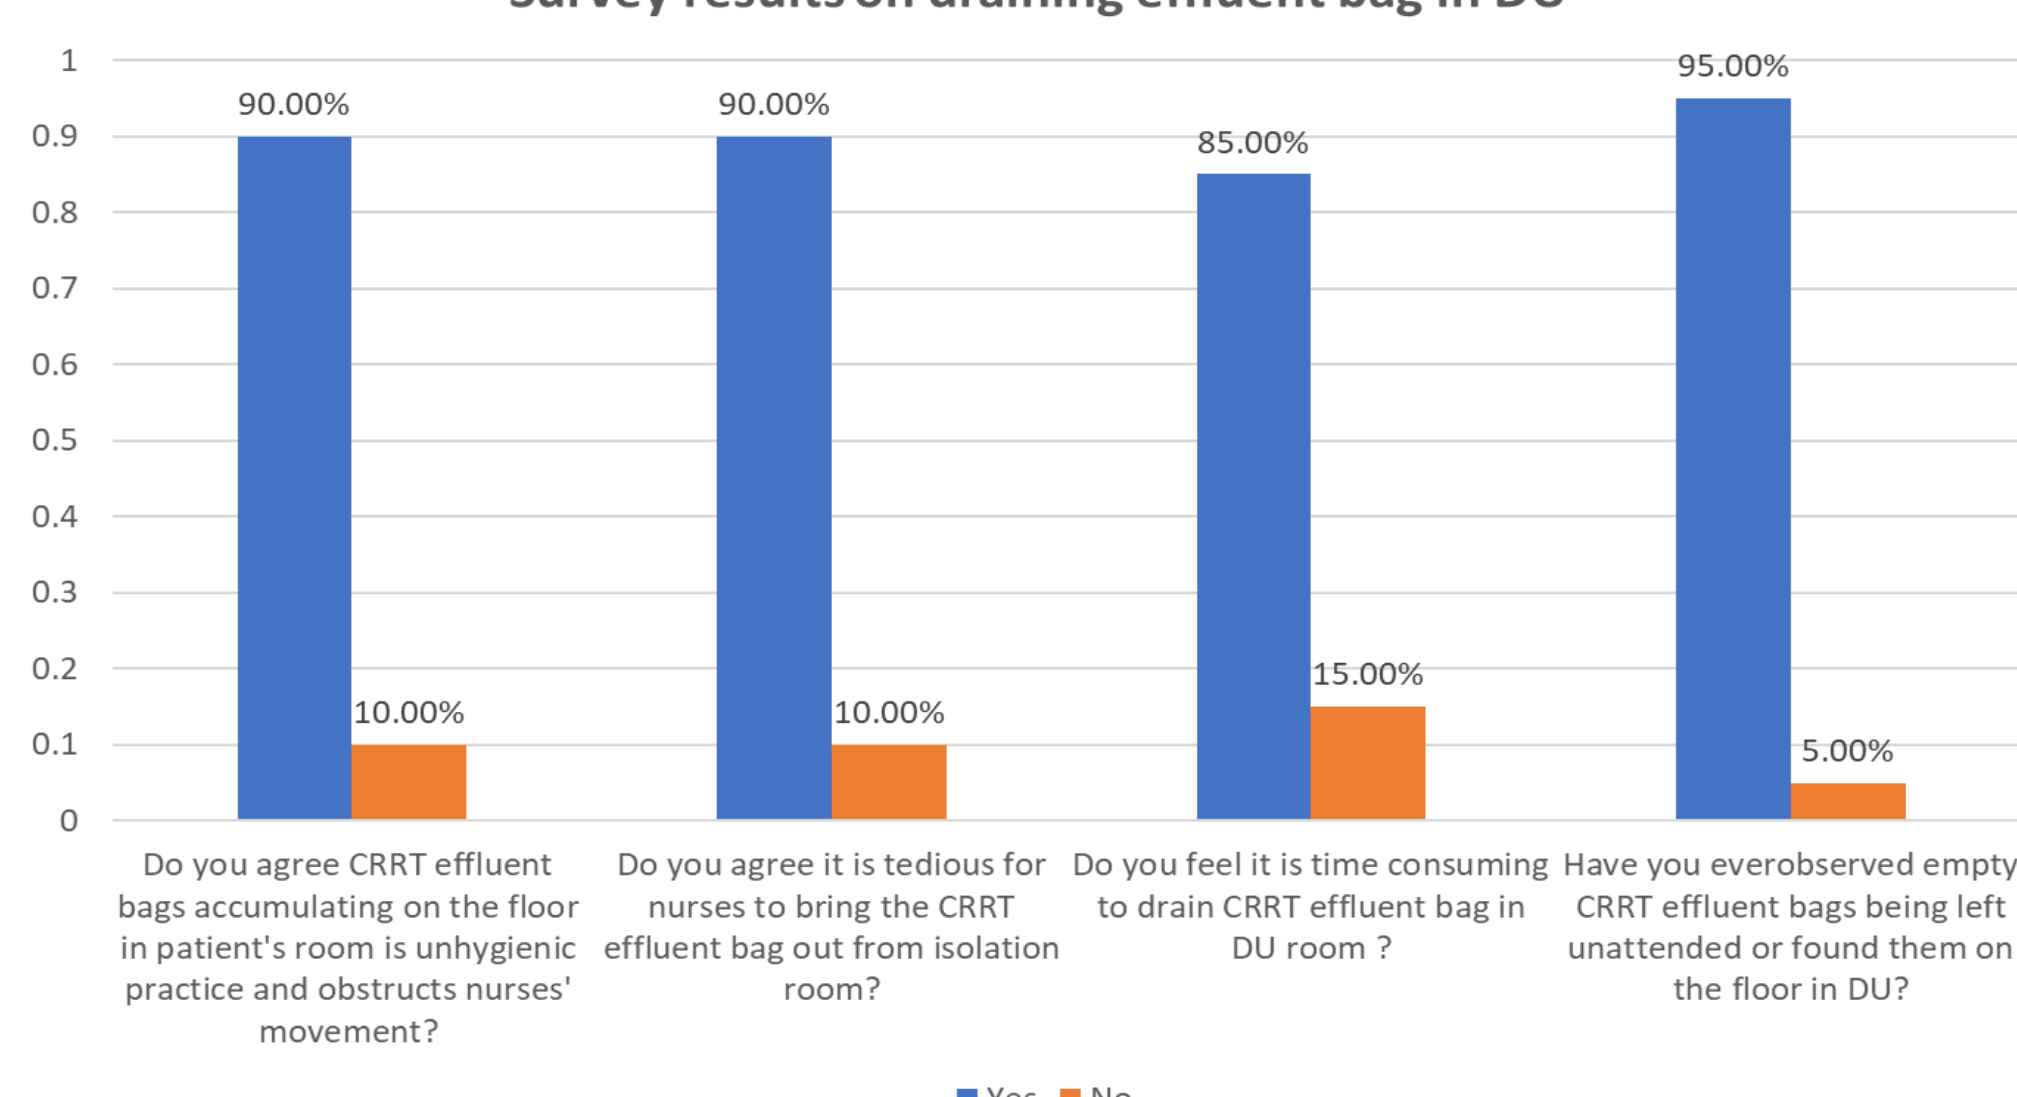
**Survey results on draining effluent bag in DU**

Survey was also conducted to understand staff perceptions of existing workflow. 95% of staff felt effluent bags left unattended in DU pose a safety hazard to healthcare workers. Majority also felt accumulating effluent bags in patients' rooms is unhygienic and obstructs movements.

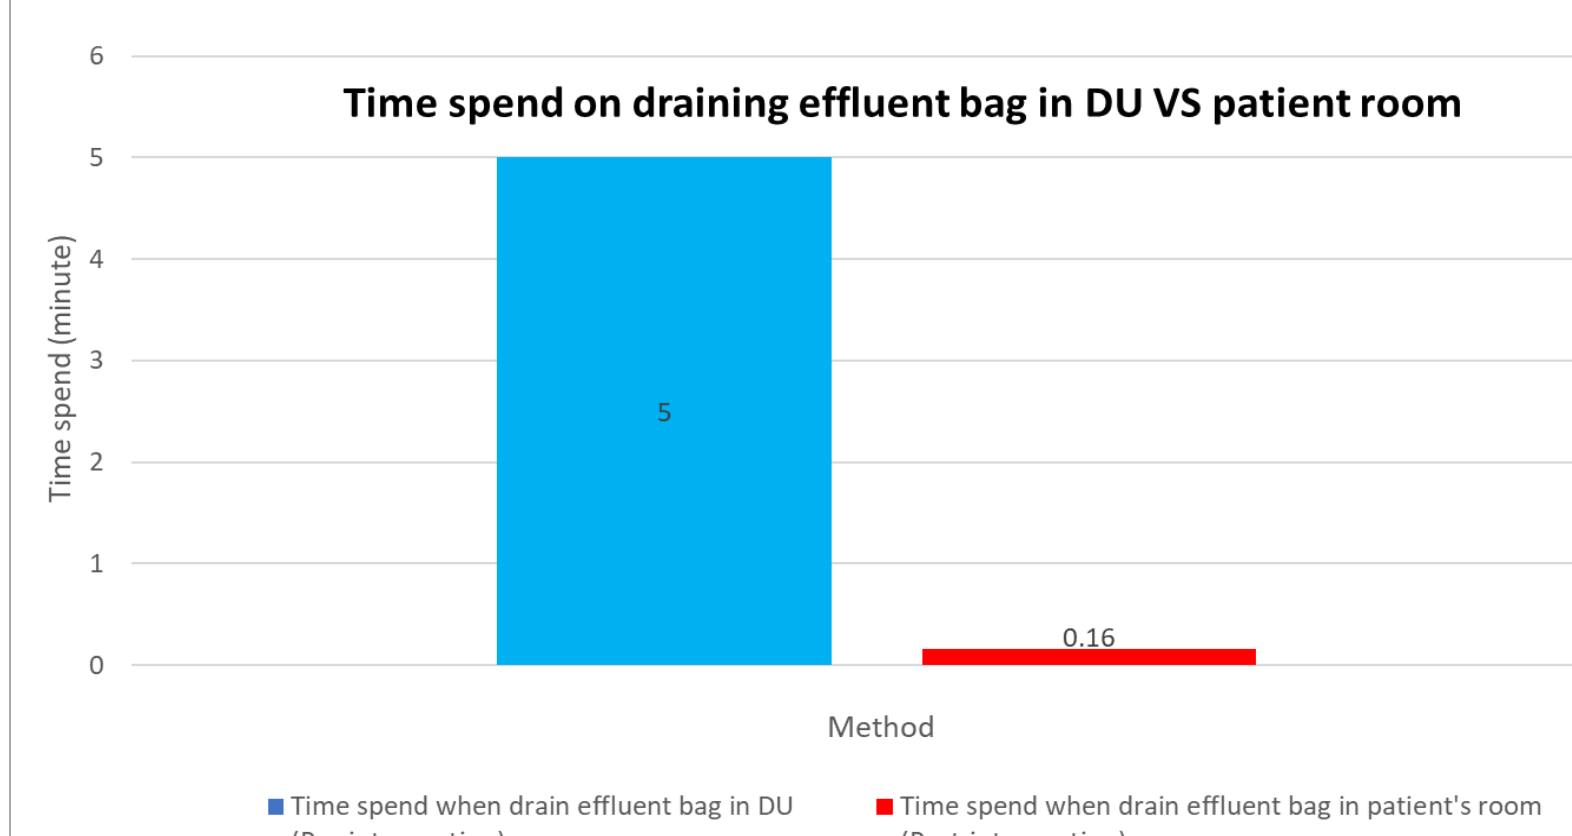
Among the various methods of draining effluent bag in dialysis cabinet, installing permanent hanger was found to be the most effective and time-saving method (time was reduced by 96% post-intervention) and it was piloted in ICU isolation rooms.

Method	Time
Pre-intervention	5 mins
Post-intervention	10 secs
<b>Time saved</b>	<b>4 mins 50 secs</b>

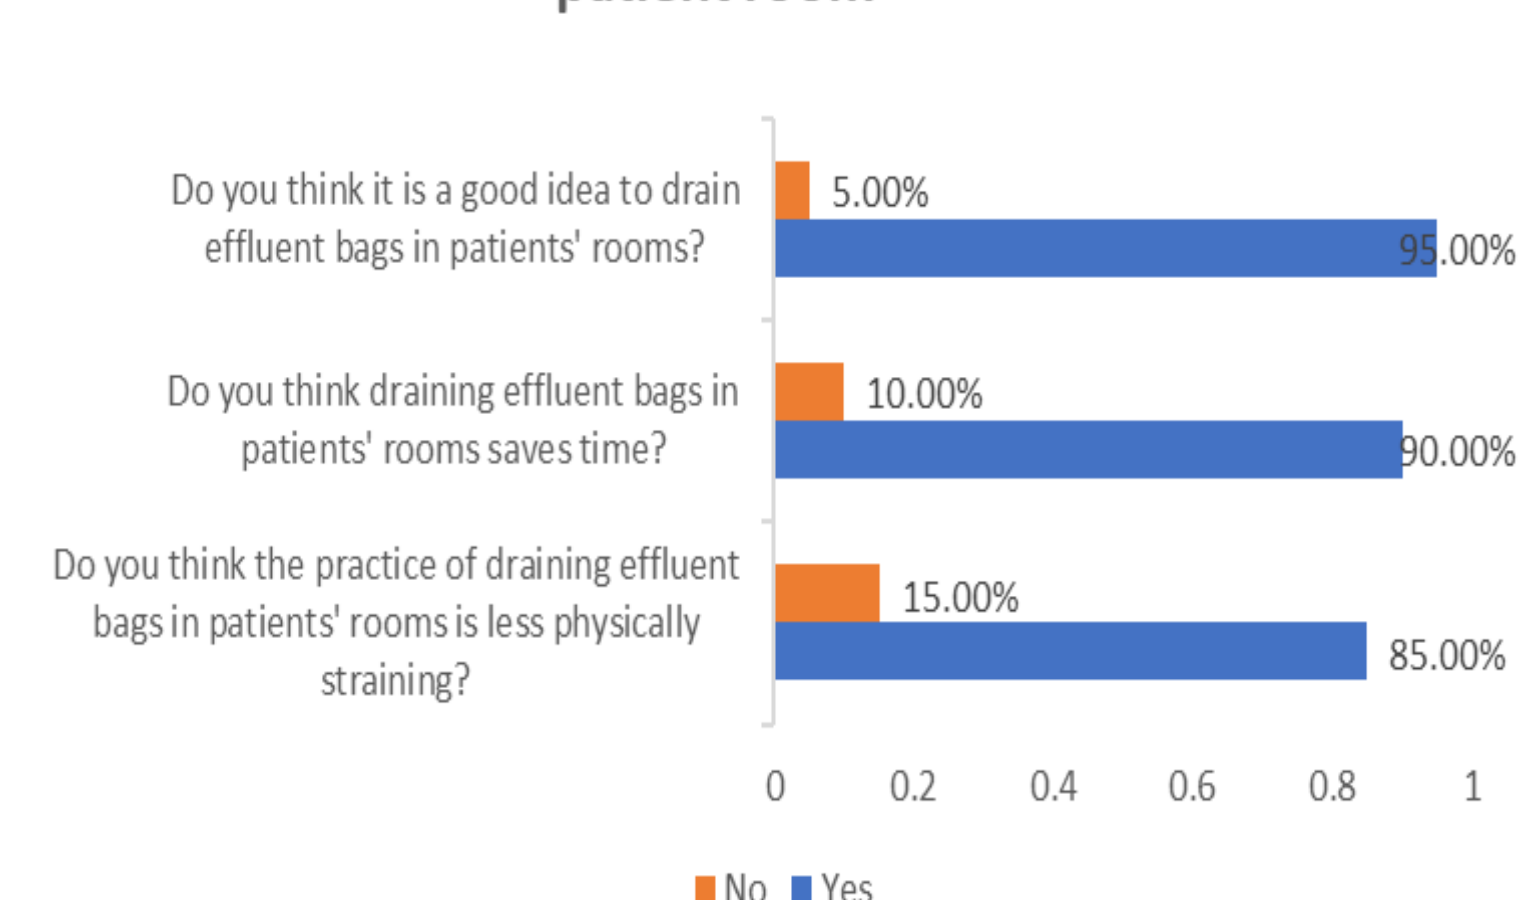
**Survey results on draining effluent bag in patient room**

Survey conducted reveals 85% to 95% of staff felt installation of permanent hanger in individual ICU room saves time and is less tedious than carrying effluent bags to DU for draining.
